**Flood Control Project Maintenance  
Levee Inspections**

**Fall 2010 Levee Maintenance Deficiency Summary Report**

**Reclamation District No. 0563 Tyler Island**

**Levee Inspection Report By Mile - Fall 2010**

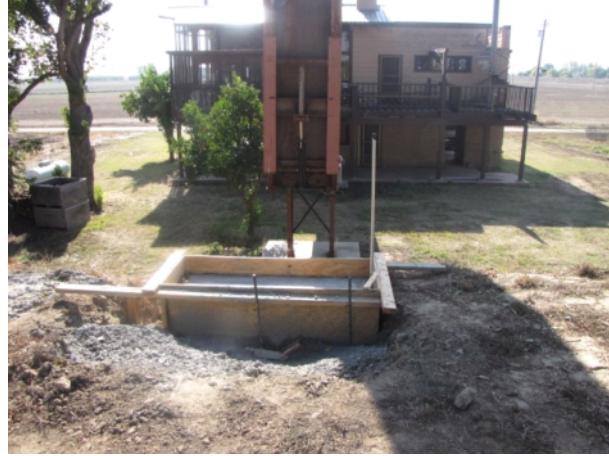
Looking east at deadman on landside shoulder.

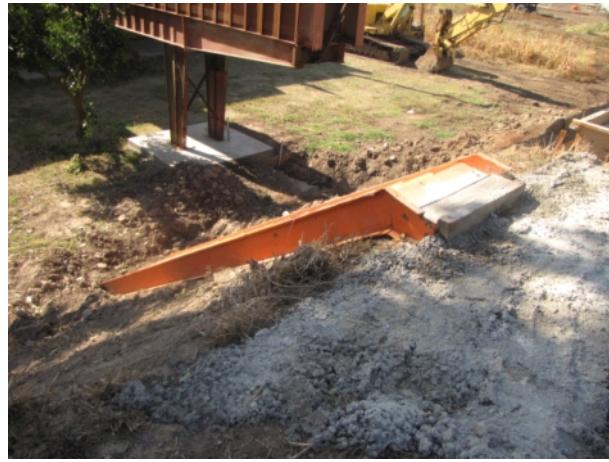
Levee Mile Report Line	21
Start Levee Mile	1.86
End Levee Mile	1.86
Location	Land Side
Category	Earthen Levee
Item	Encroachments

Looking southeast at temporary metal stairs on landside slope.

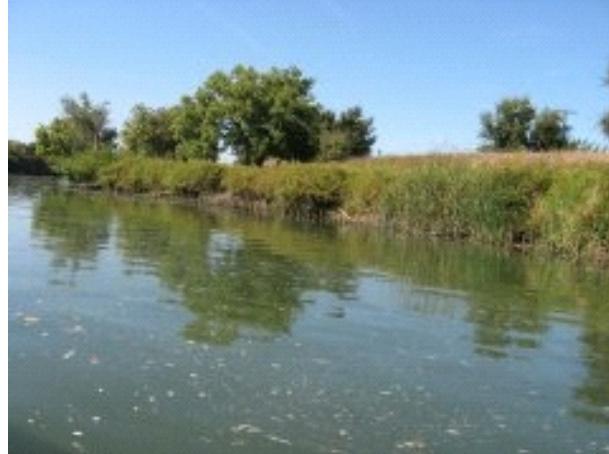
Levee Mile Report Line	31
Start Levee Mile	2.68
End Levee Mile	2.87
Location	Water Side
Category	Supplemental
Item	USACE Erosion Survey
2009: 10 ft berm, 1:1 slope, no stability issues, clays and silts, 1.07 ft/s [2009 SiteID:GEO_9-3_L]	
richard_f_20100921_176.JPG

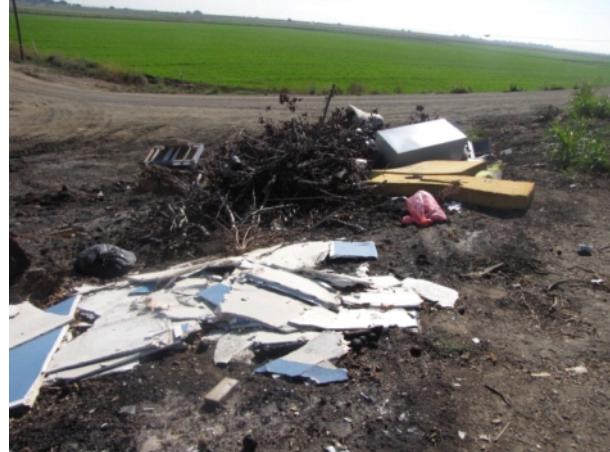
Levee Mile Report Line	33
Start Levee Mile	2.94
End Levee Mile	2.94
Location	Land Side
Category	Earthen Levee
Item	Encroachments
Looking south at pruning and garbage pile on landside slope	
richard_f_20101029_369.jpg

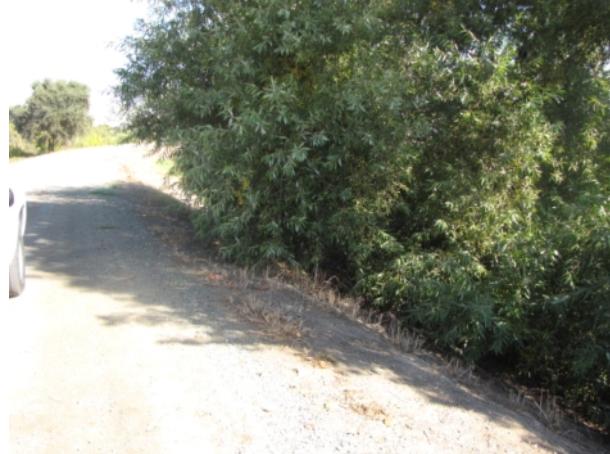
Levee Mile Report Line	38
Start Levee Mile	3.28
End Levee Mile	3.28
Location	Land Side
Category	Earthen Levee
Item	Trim / Thin Trees
Looking southeast at dense tree on landside slope and toe.	
richard_f_20101029_370.jpg

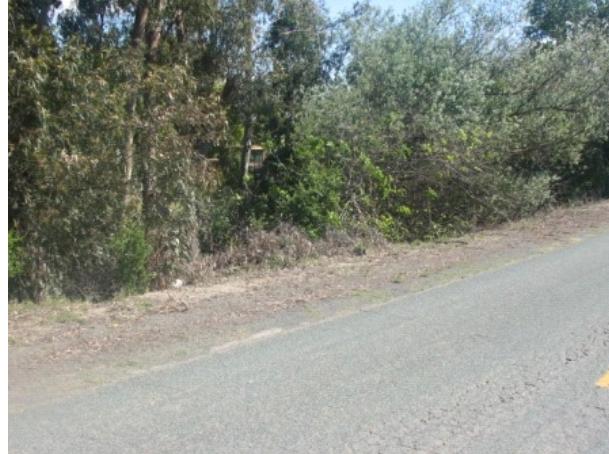
Levee Mile Report Line	54
Start Levee Mile	6.90
End Levee Mile	6.94
Location	Land Side
Category	Earthen Levee
Item	Trim / Thin Trees
Front view of dense trees along landside shoulder and slope.	
richard_f_20100921_175.jpg

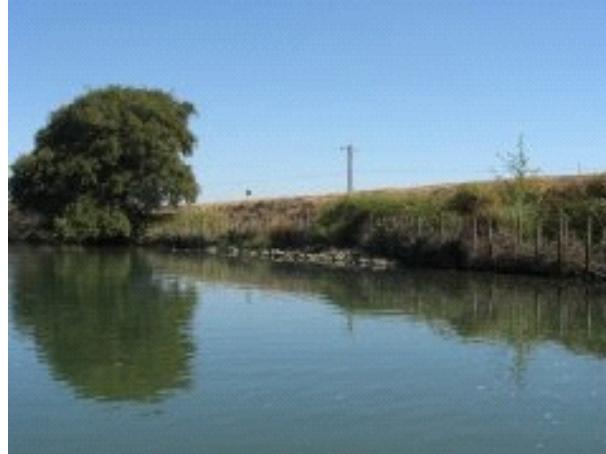
Levee Mile Report Line	61
Start Levee Mile	8.29
End Levee Mile	8.39
Location	Water Side
Category	Supplemental
Item	USACE Erosion Survey
2009: 5 ft berm, 1:1 slope, no stability issues, clays and silts, 3.76 ft/s [2009 SiteID:GEO_4-0_L]	
richard_f_20100921_185.JPG

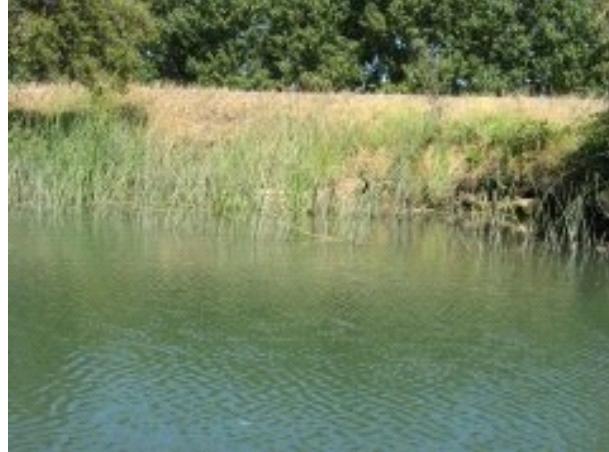
Levee Mile Report Line	64
Start Levee Mile	8.55
End Levee Mile	8.75
Location	Water Side
Category	Supplemental
Item	USACE Erosion Survey
2009: 5 ft berm, 2:1 slope, holes, clays and silts, 4.04 ft/s [2009 SiteID:GEO_3-6_L]	
richard_f_20100921_189.JPG

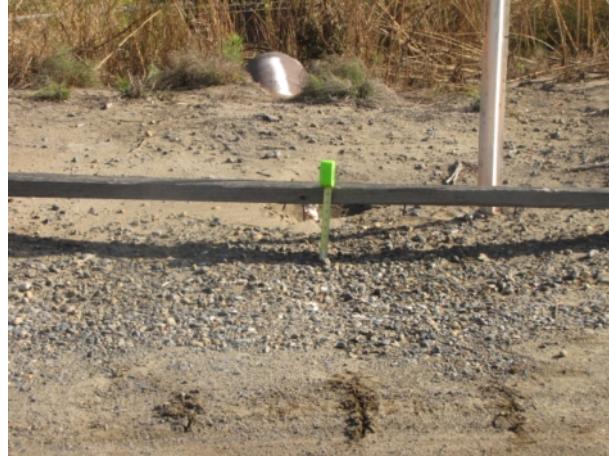
Levee Mile Report Line	71
Start Levee Mile	10.06
End Levee Mile	10.06
Location	Crown
Category	Earthen Levee
Item	Crown Surface / Depressions / Rutting
Looking east at depression above ten inches irrigation pipe (possible collapse pipe) on landside shoulder.	
richard_f_20101029_374.jpg

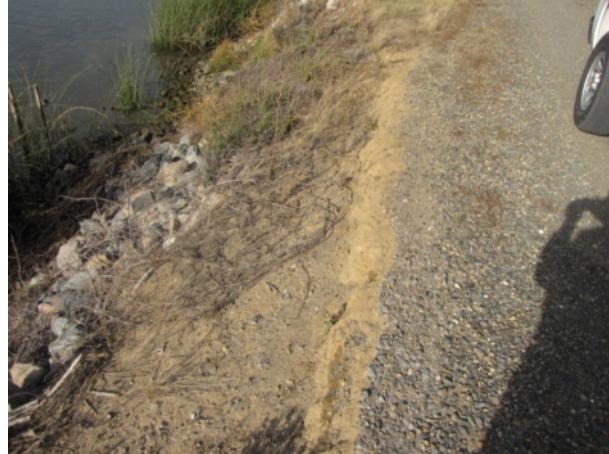
Levee Mile Report Line	73
Start Levee Mile	10.44
End Levee Mile	10.44
Location	Water Side
Category	Earthen Levee
Item	Erosion / Bank Caving
Looking northwest at updated picture of erosion site on waterside slope and shoulder as of October 2010.	
richard_f_20101029_378.jpg

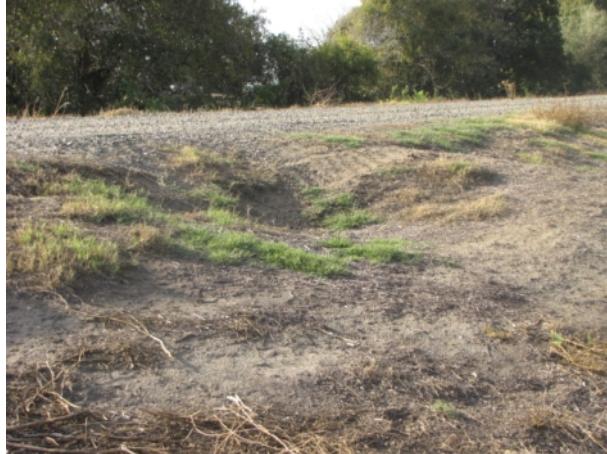
Levee Mile Report Line	75
Start Levee Mile	10.77
End Levee Mile	10.77
Location	Land Side
Category	Earthen Levee
Item	Slope Stability
Looking west at depression on landside shoulder and slope.	
richard_f_20101029_380.jpg
